# DINCEL'S KNOWLEDGE

## NO: 2 CASE STUDY

### **Case Study:** Dincel Water Tank

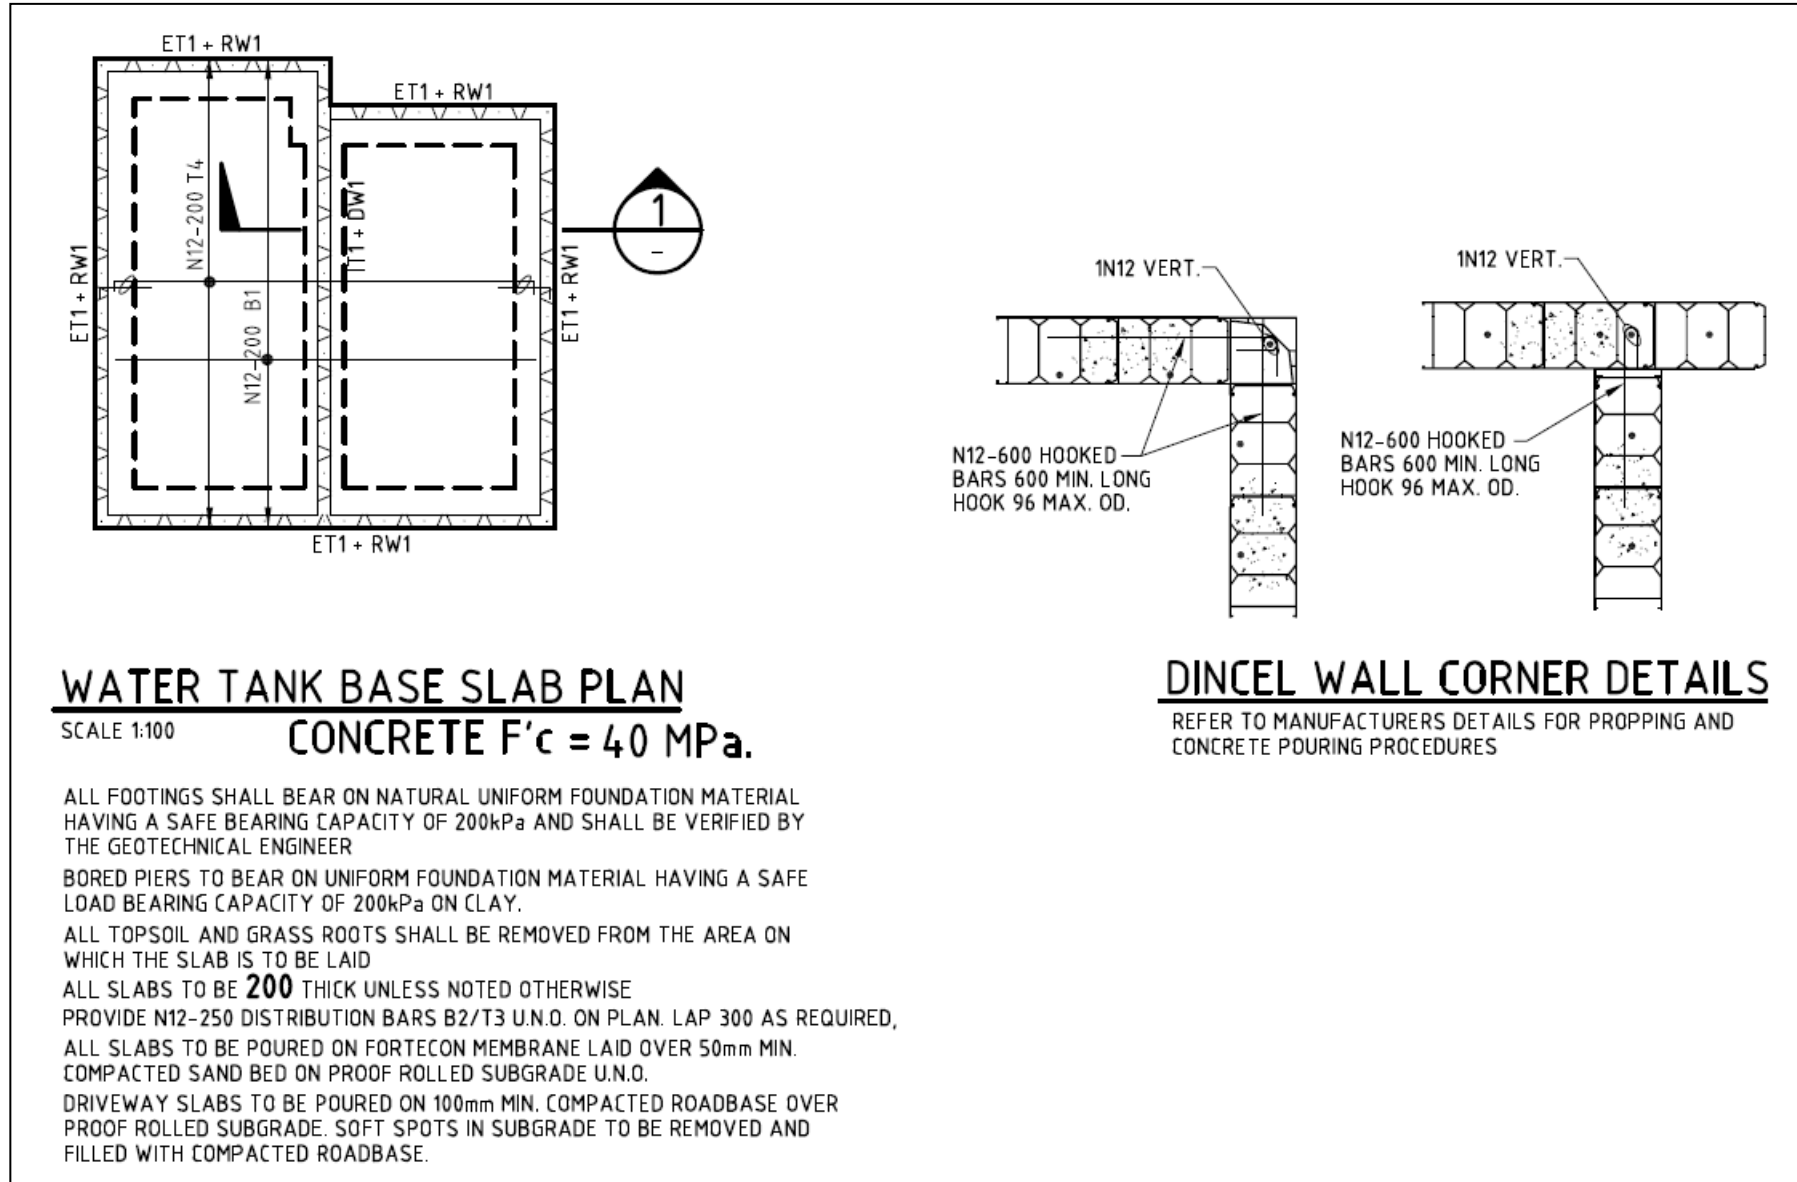
Figure 1

The base of the tank is a reinforced concrete raft slab while the walls are 200mm Dincel wall panels reinforced vertically only, i.e. no horizontal reinforcement used. The only horizontal reinforcements are those at the corners comprised of N12-600 centers, 600 long hooked bars. Refer to **Figures 1 and 2** below.

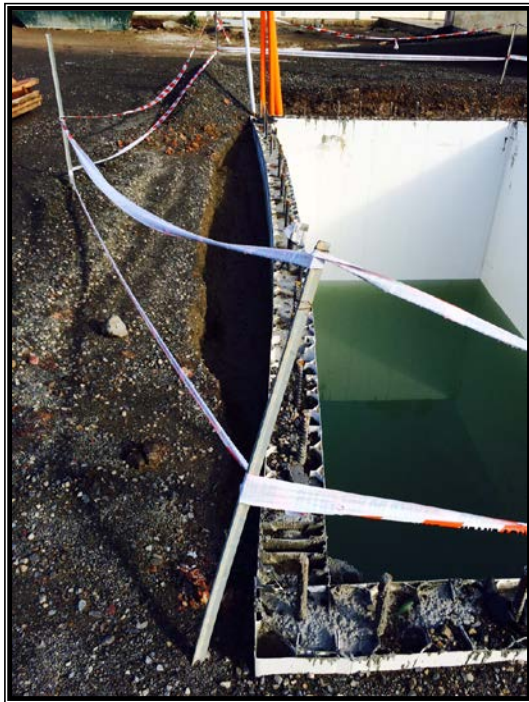
Days after the walls were poured the site suffered continuous torrential rain for approximately five (5) days. The water and soil were deposited behind the tank walls without top restraints causing the wall to shift approximately 100mm (span/66) from plumb position. Refer to **Photo No: 1**.

**Photo No: 1 – Shows Displaced Wall**

The displaced tank wall exhibits a ductile behavior horizontally when there was no horizontal reinforcement in the wall. The vertical steel reinforcement is dowelled to the base slab meaning that there are no possible cantilever action can be expected from this. The wall therefore theoretically has a limited stiffness and strength horizontally. The wall horizontal behaviour was not expected from a vertically designed wall.

It appears that the PVC skin of the Dincel panels provided the diaphragm action in the absence of horizontal steel in this case. The 100mm or span/66 displacement is considered excessive and traditionally reinforced concrete structures are not expected have this degree of displacement. **Photos No: 3 and No: 4** show the finished tank.

After the rain, the backfill behind the wall was removed and horizontal props were installed at the top of the wall. The props were also used to push the wall back into position as shown in **Photo 2**. There were no visible defects noted to the wall when inspected.

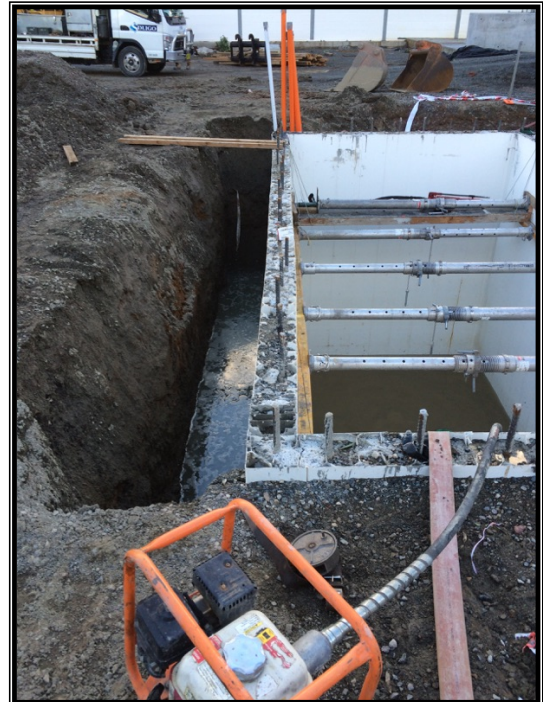
**Photo No: 2 – Shows Rectified Wall**

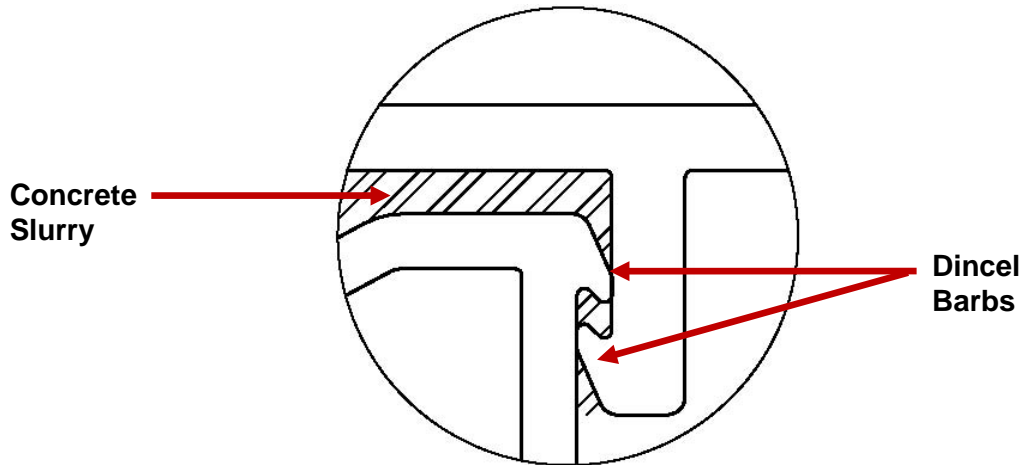
Dincel Patented Panel Joint

The subject wall would have collapsed if Dincel Wall panels did not have the special barbs (similar to clutches of sheet piling) shown below.

**Barbs ensure that the panel connection does not slip under pressure thus ensuring the entire wall acts monolithically.**

This patented panel joint was originally developed to ensure that waterproofing without the use of membrane is achieved. For detailed information [\(download\) Dincel Wall Waterproofing, Page 9.](#)
