# CorrAssure™ CORROSION SURVEY OF A COMMERCIAL OFFICE BUILDING

Commercial Office Building

Coastal, Australia

RemedyAP were engaged to provide their CorrAssure™ retroactive process in identifying the corrosion issues on the exterior surfaces.

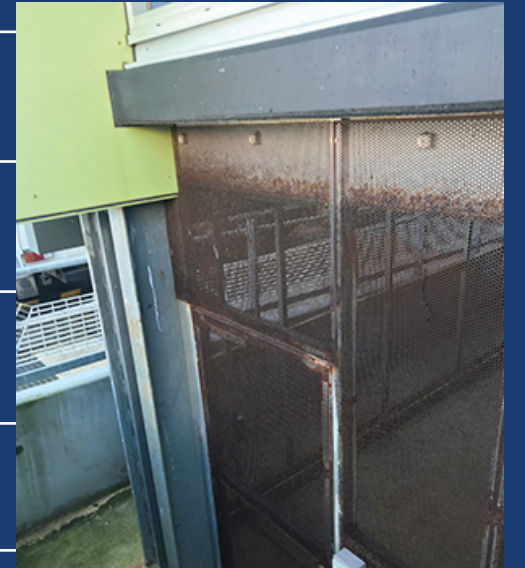
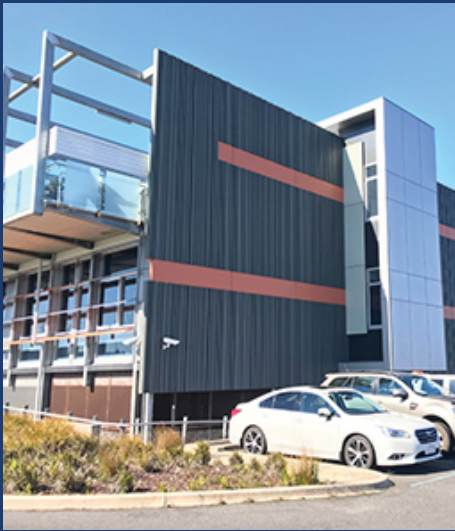
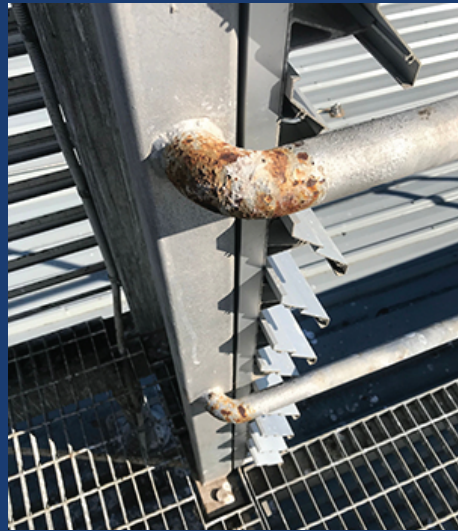
Connection of dissimilar metals are frequent in construction. This isn't always detrimental depending on the materials and fixing methods. RemedyAP performed a material audit of the external surfaces and found some galvanic coupling that was contributing to corrosion of galvanized surfaces.

Our CorrAssure™ condition assessment identified an area of significant corrosion due to galvanic coupling. RemedyAP were able to provide a construction specification for replacement and improvement of the screening to meet long term corrosion resistance.
