TEMPORARY FENCING

THE AUSTRALIAN TRELLIS DOOR CO.

S04-1 FLOOR LOCKING

TESTED BY
AZUMA DESIGN PTY LTD

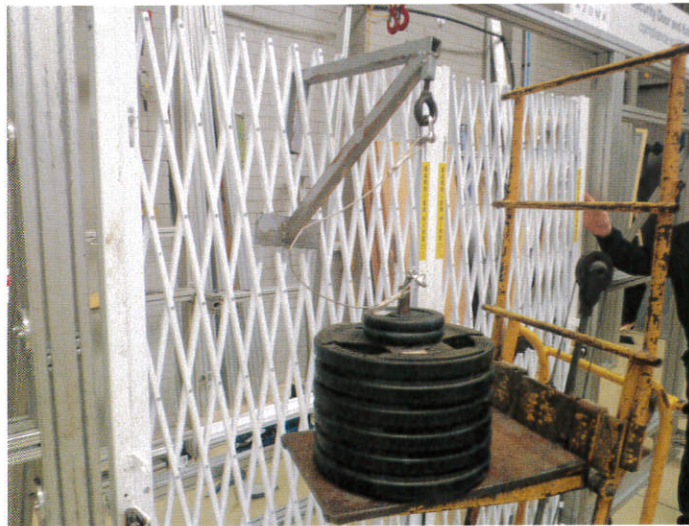
Figure 1: Simulated Climbing Test

1. A test apparatus with a lever arm of 400 mm is attached to the top centre of the infill panel.
2. A 65 kg weight is then attached to the end of the lever arm and left to hang freely
3. The weight is suspended for a period of 3 minutes
4. The load is removed after 3 minutes and the specimen is inspected for damage to the infill panel and structural members

Weight Used	65 ± 0.5 kg
Time Elapsed	3 minutes
Signs of Breakage/Damage or Failure	Nil
Result	Pass

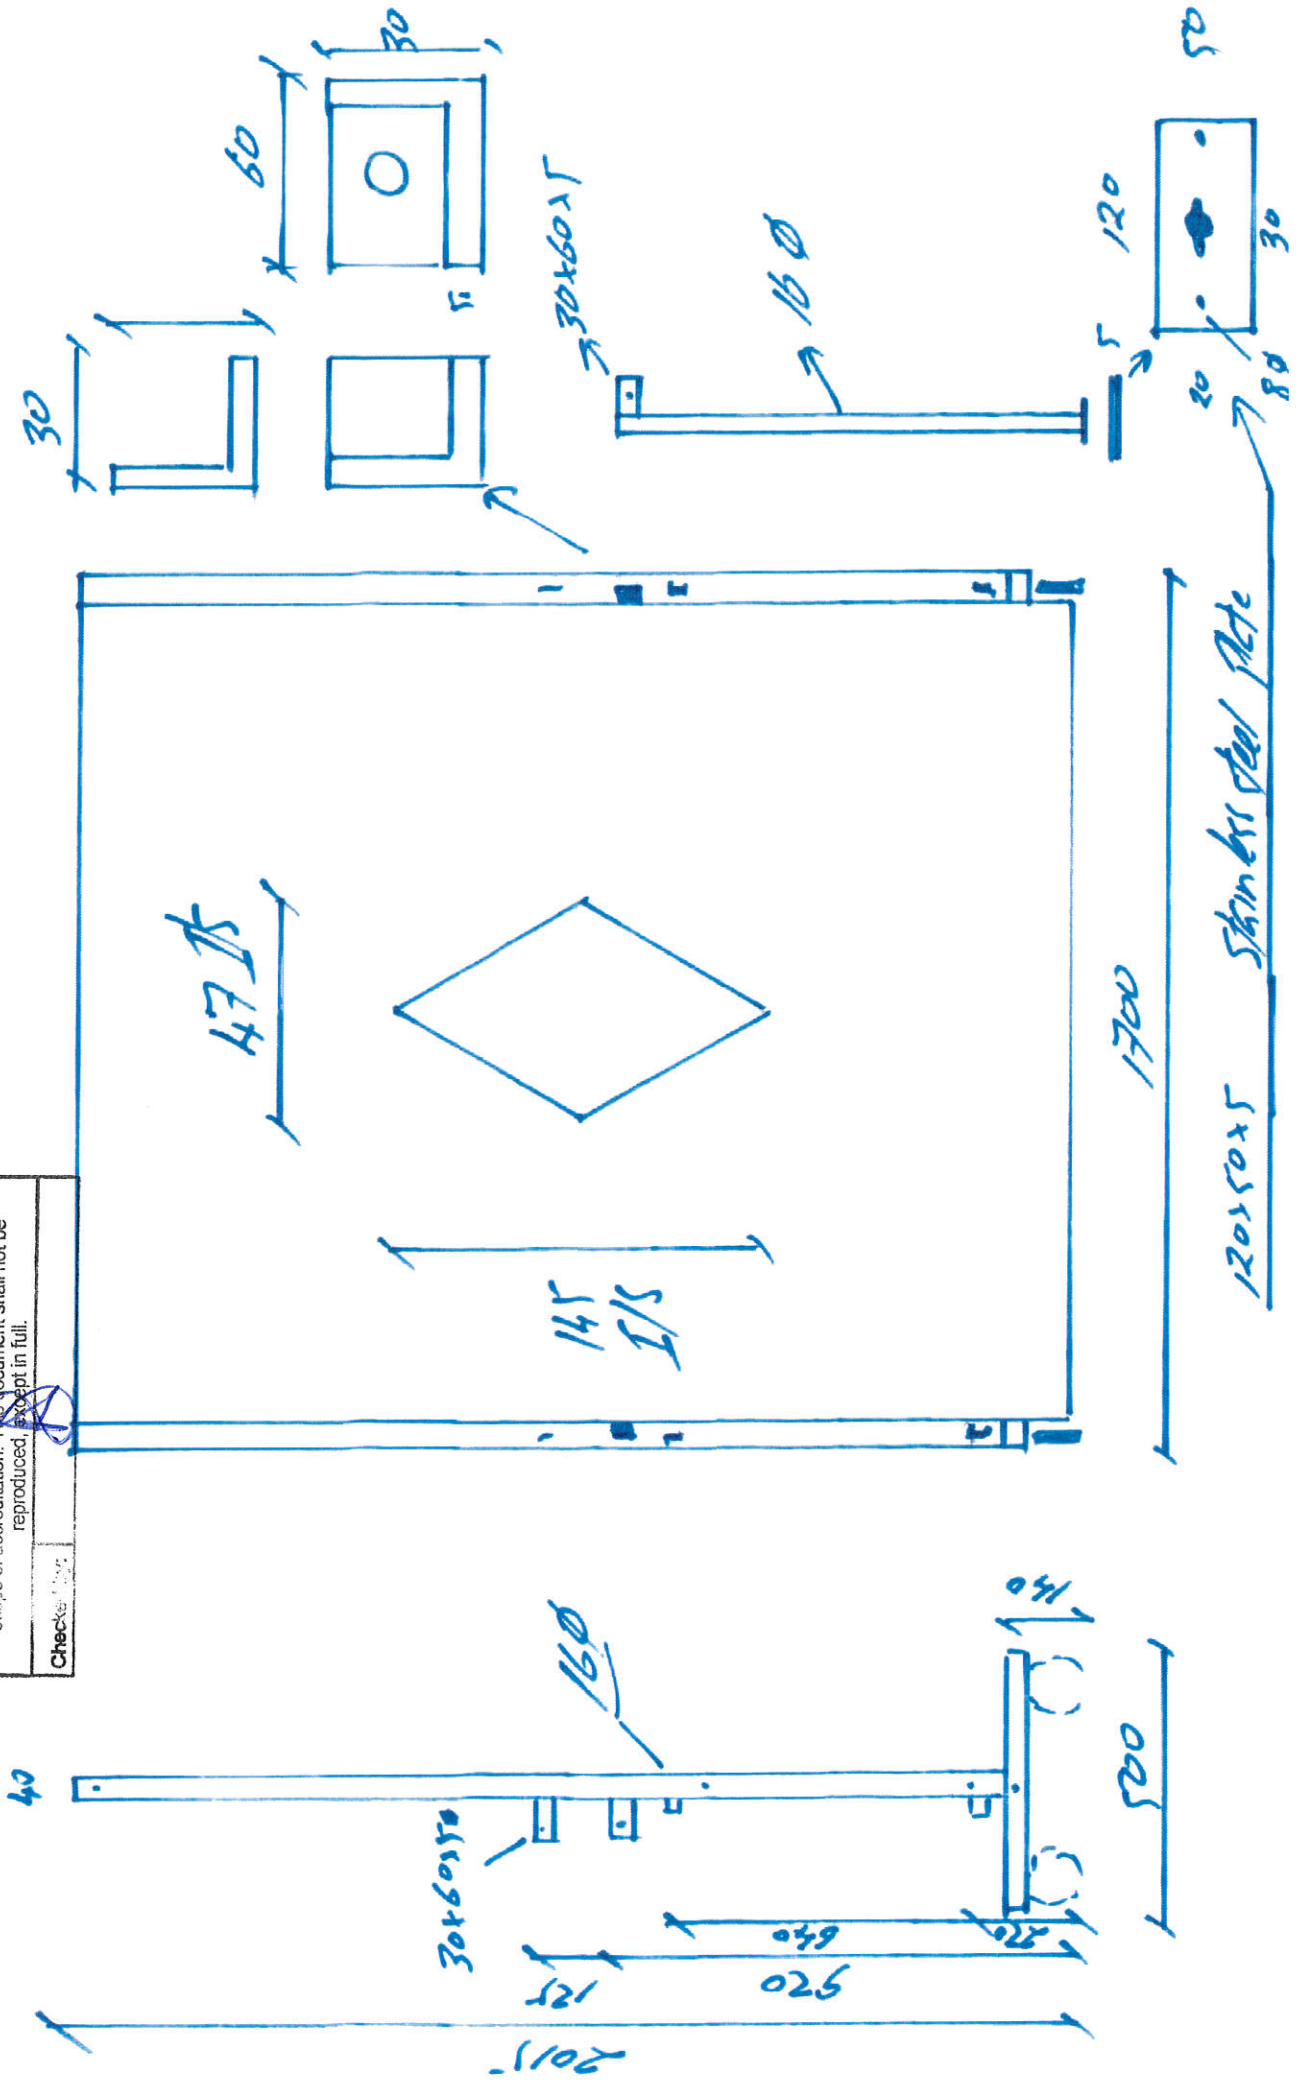
Double Diamond Frame
Looking to floor

Product Description	Fence panels are connected to vertical posts with two castor wheels for each post. Two panels are joined together with three bolts on each post to be slotted into the floor locking plate. See attached drawing for more details.
Dimensions	Width - 2050 mm Height - 2015 mm
Locking Method	Three point locking, 14 mm steel rods placed at each vertical post locking into the finished ground level lock plates
Opening Shape	Diamond
Openings (Interior Dimensions)	310 mm x 75 mm - corner to corner dimensions (see drawing for more detail)
Meets Height Requirement (1500 mm Minimum)	Yes 2015 mm
